STRUCTURAL INTEGRITY RESERVE STUDY

Colonial House Association, Inc.

**230 Columbia Dr.
Cape Canaveral, Florida 32920**

Project Number: 2426076

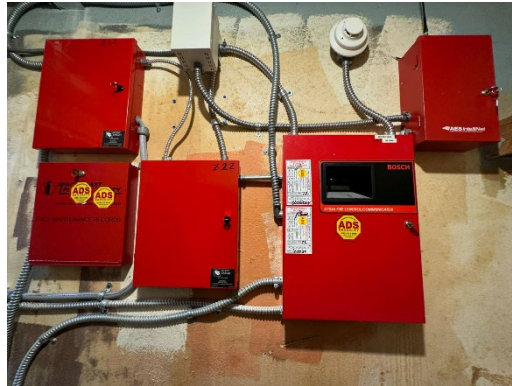
Photo 13

View of Fire Alarm Control Panel

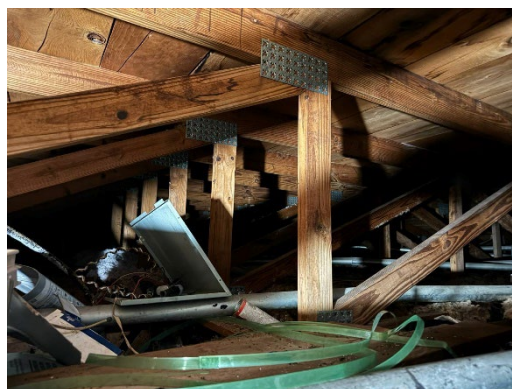
Photo 15

View of Wood Truss System

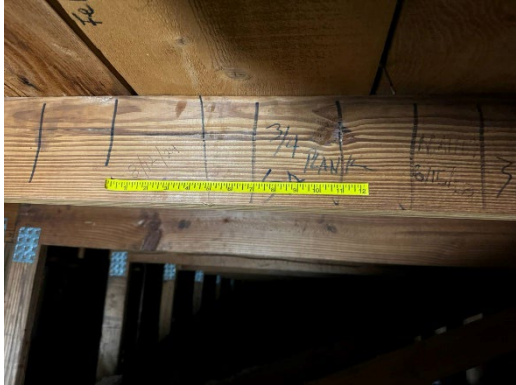
Photo 18

View of Roof Sheathing Nailing Pattern

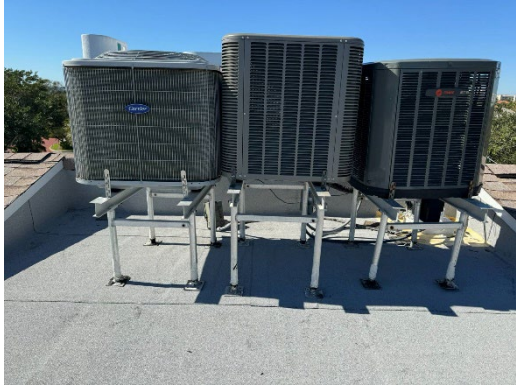
Photo 21

General View of HVAC Equipment on Rooftop

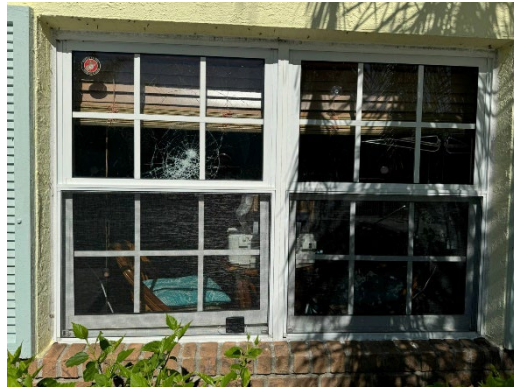
Photo 22

View of Damaged Window

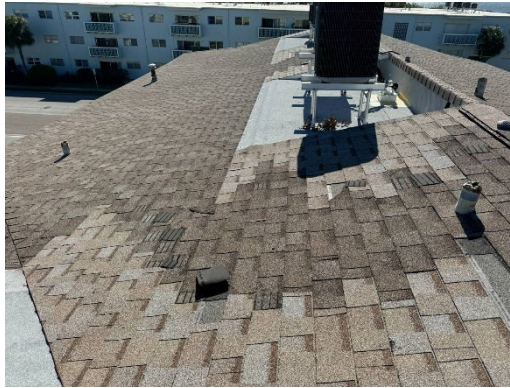
Photo 25

Both the Flat (low-sloped) and Sloped sections of the roof are supported by a wood truss system. The flat section of the roof is covered with Modified Bitumen. The sloped portions of the roof are covered with asphalt shingles. There were scattered areas of missing shingles on the sloped sections of the roof. The roof coverings were otherwise observed to be in good condition. The roof coverings were reported to have been replaced Assumed 2023. Funds have been spread throughout the Reserves Table to ensure the availability of funds at the end of the element's EUL.

View of Missing Shingles

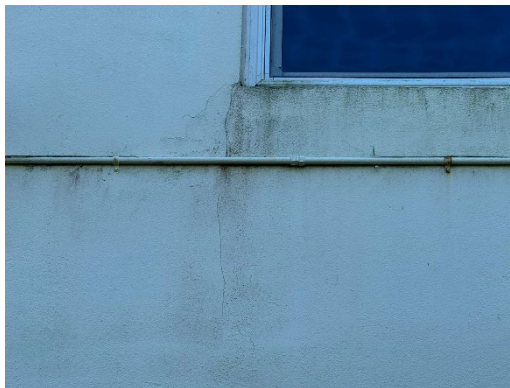
Photo 26

View of Minor Stucco Cracking

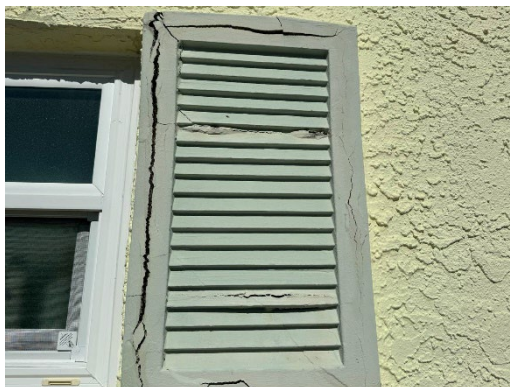
Photo 27

View of Deterioration to Cosmetic Shutters
